**NL INDUSTRIES/TARACORP SUPERFUND SITE GROUP**  
**Leed Environmental, Inc.**  
**Van Reed Office Plaza**  
**2209 Quarry Drive, Suite C-35**  
**Reading, PA 19609**  
**Telephone: (610) 670-7310**  
**Facsimile: (610) 670-7311**

November 19, 2019

**Re: NL Industries/Taracorp Superfund Site; Granite City, Illinois**  
**Second 2019 Semi-Annual Operation and Maintenance Inspection (November 2019)**

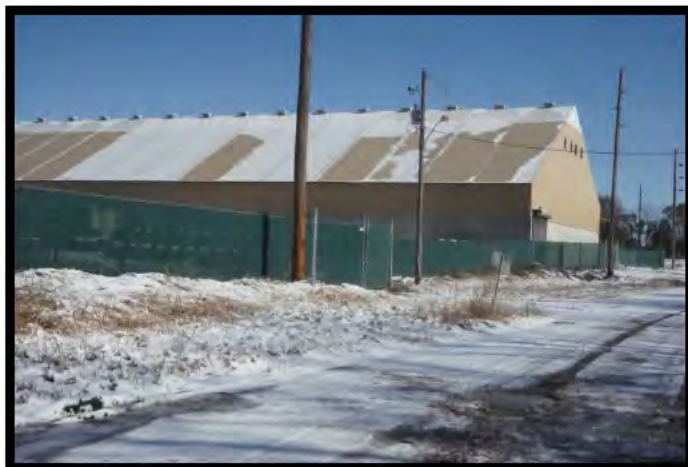
Photograph 1: Beelman storage area/warehouse (view along Bremen Street).

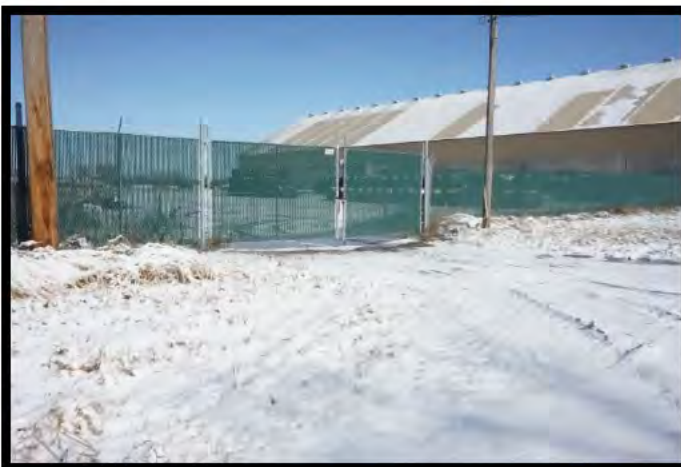
Photograph 2: Fence/gate (view from Bremen Street).

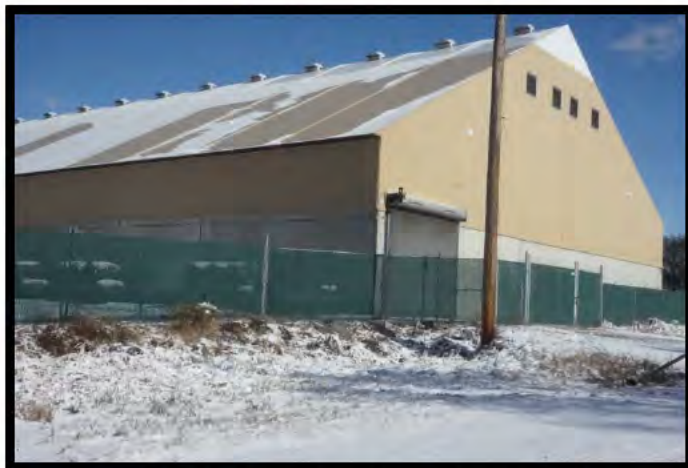
Photograph 3: Beelman storage area/warehouse (view along Bremen Street).

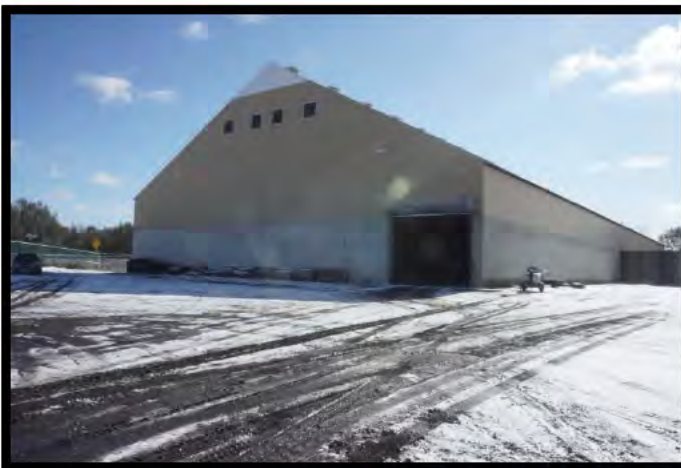
Photograph 4: Beelman storage area/warehouse.

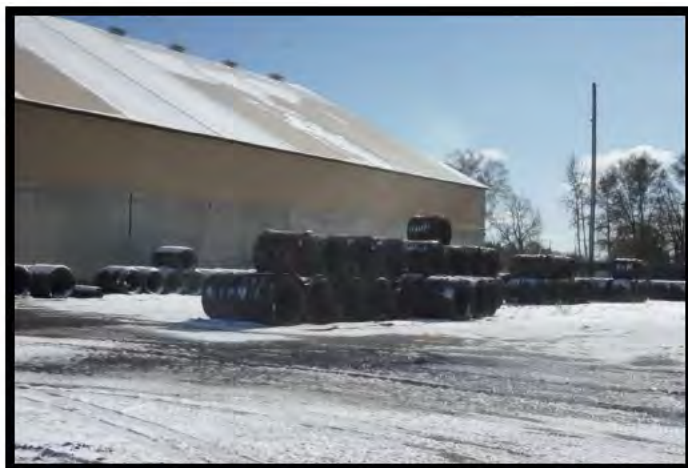
Photograph 5: Beelman storage area/warehouse.

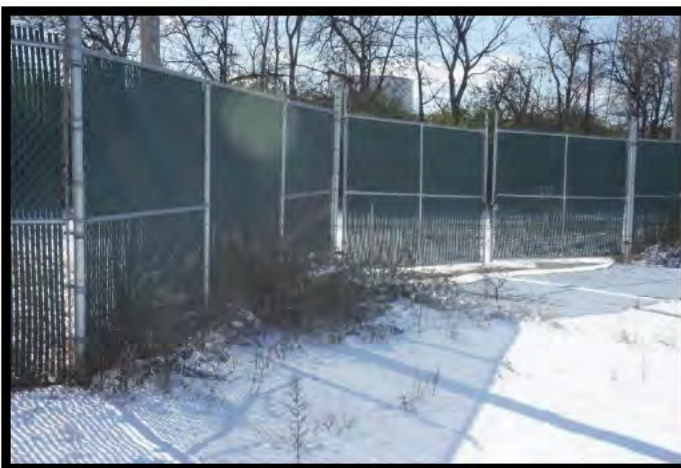
Photograph 6: Slough Road, inside fence (along Bremen Street).

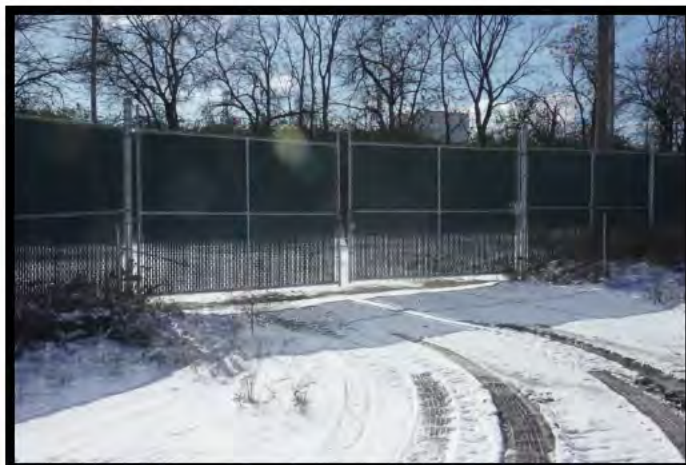
Photograph 7: Slough Road, inside fence (along Bremen Street).

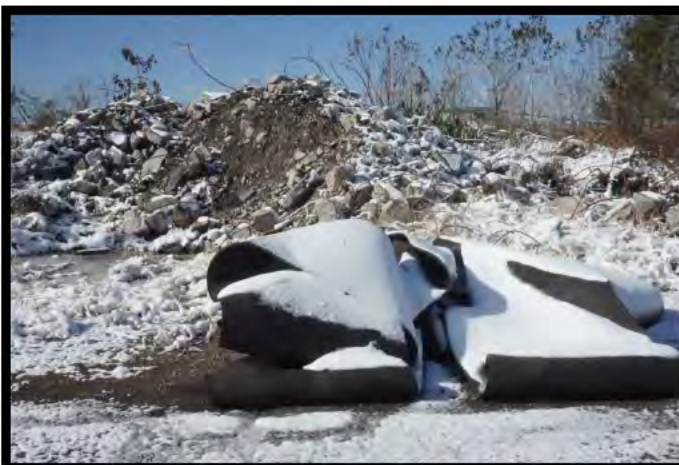
Photograph 8: Slough Road, concrete debris.

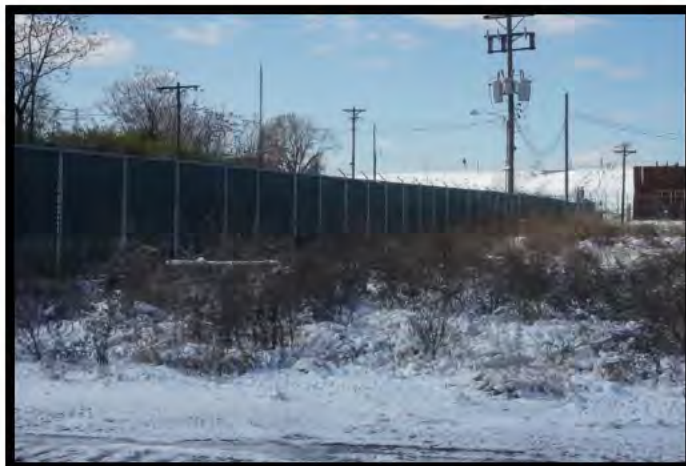
Photograph 9: Slough Road, inside fence (along Bremen Street).

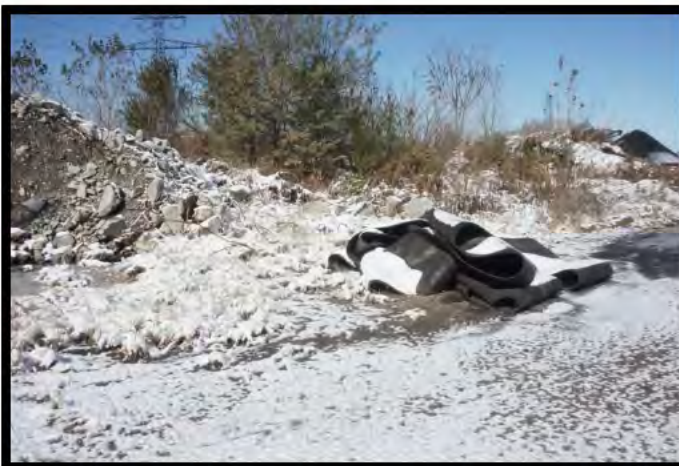
Photograph 10: Slough Road, concrete debris.

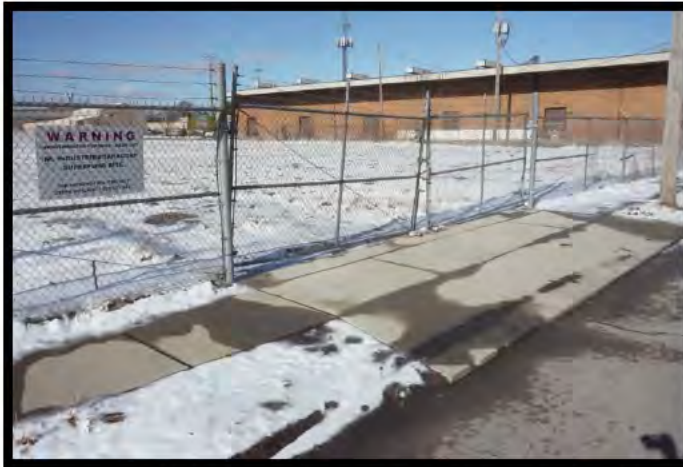
Photograph 1: Entrance to 1555 State Street property along State Street.

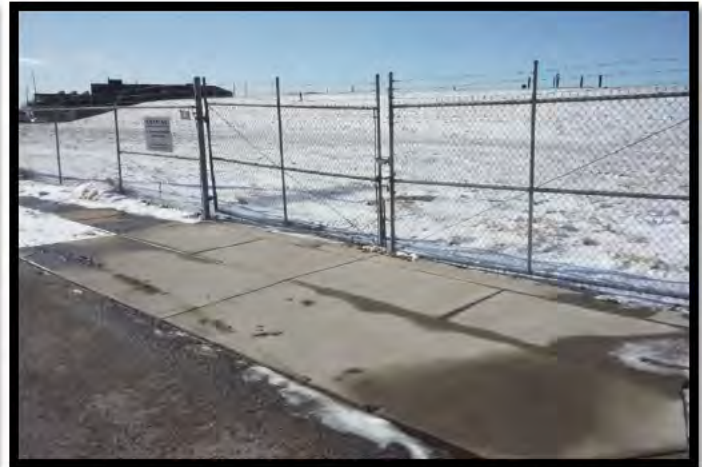
Photograph 2: Entrance to 1555 State Street property along State Street.

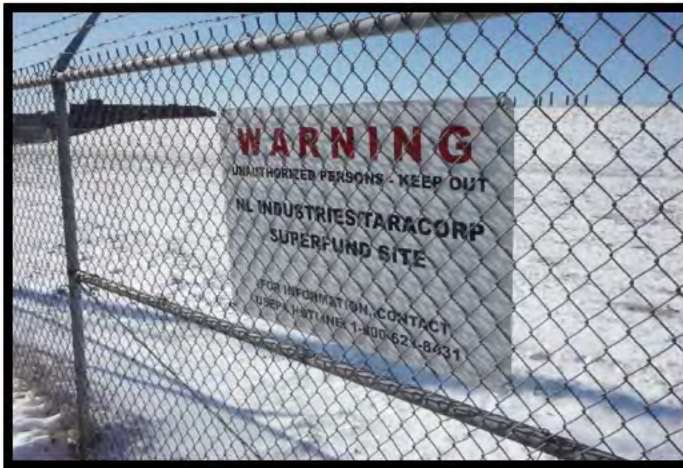
Photograph 3: Warning sign at front gate along State Street.

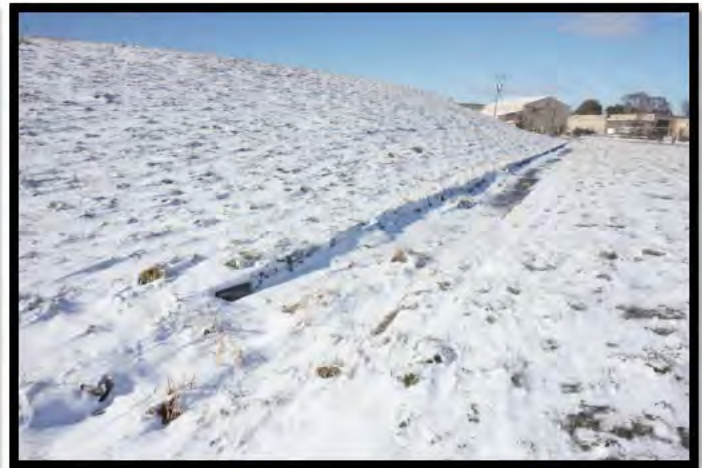
Photograph 4: Concrete drainage swale, east side of Taracorp pile (view north).

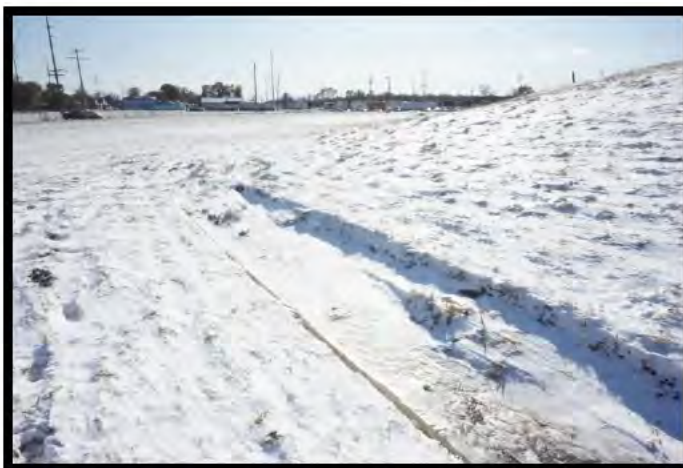
Photograph 5: End of concrete drainage of swale, east side of Taracorp pile.

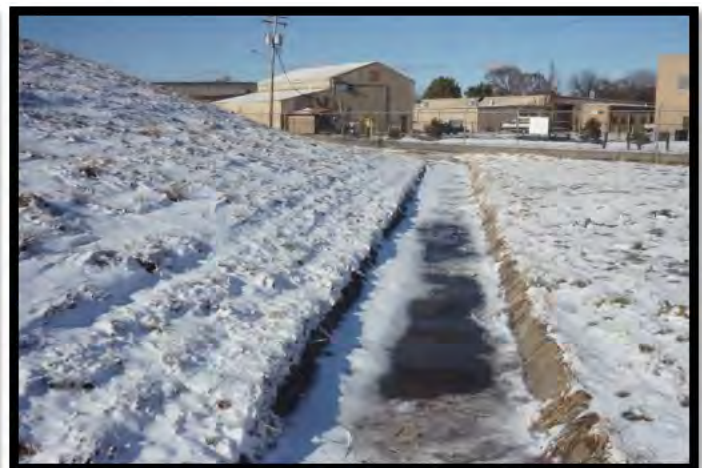
Photograph 6: Concrete drainage swale, east side of Taracorp pile (view north).

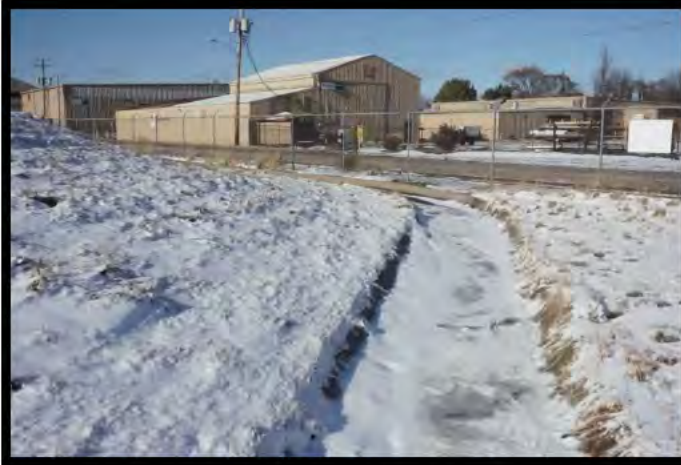
Photograph 7: Concrete drainage swale, east side of Taracorp pile (view north).

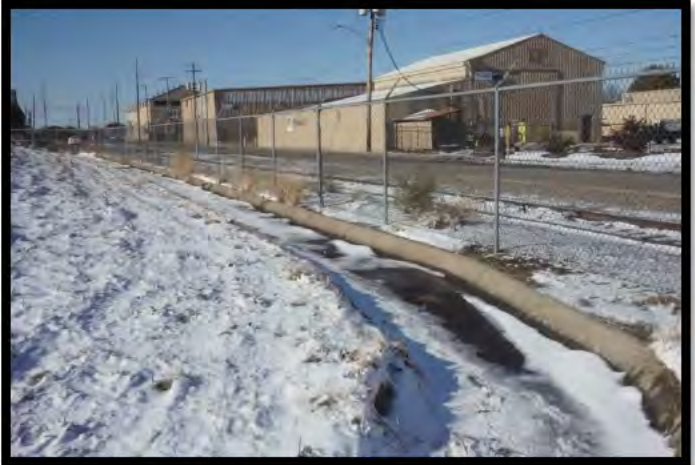
Photograph 8: Concrete drainage swale, east side of Taracorp pile (view north).

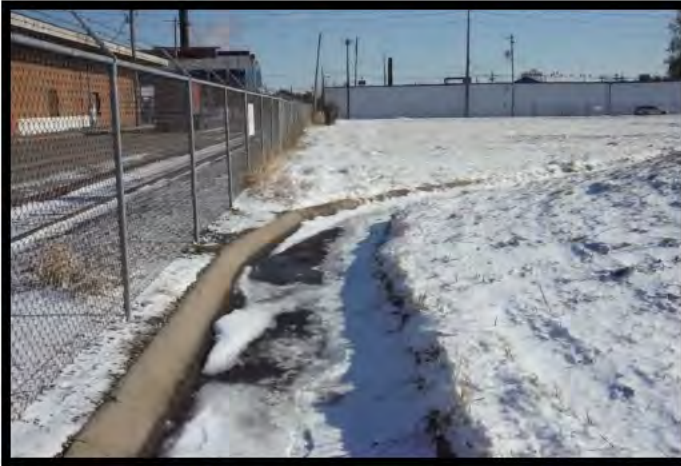
Photograph 9: Concrete drainage swale, north side of Taracorp pile (view southeast).

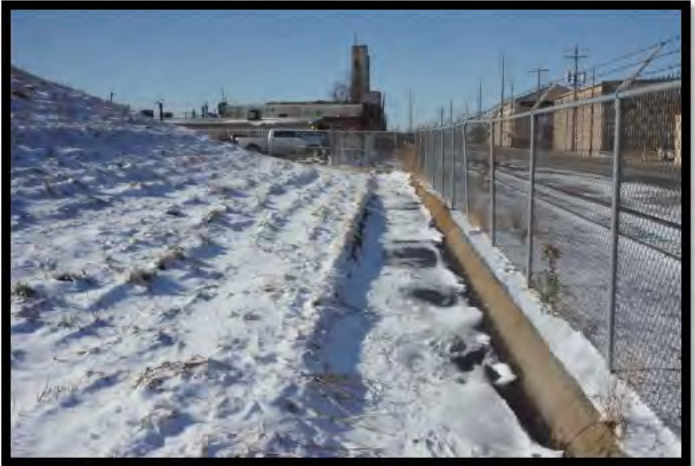
Photograph 10: Concrete drainage swale, fence, and vegetation; north side of Taracorp pile along 16<sup>th</sup> Street (view northwest).

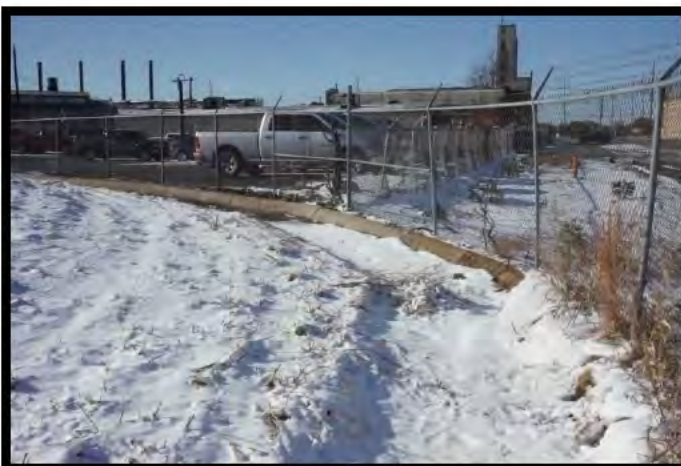
Photograph 11: Concrete drainage swale, fence, and vegetation; north side of Taracorp pile along 16<sup>th</sup> Street (view northwest).

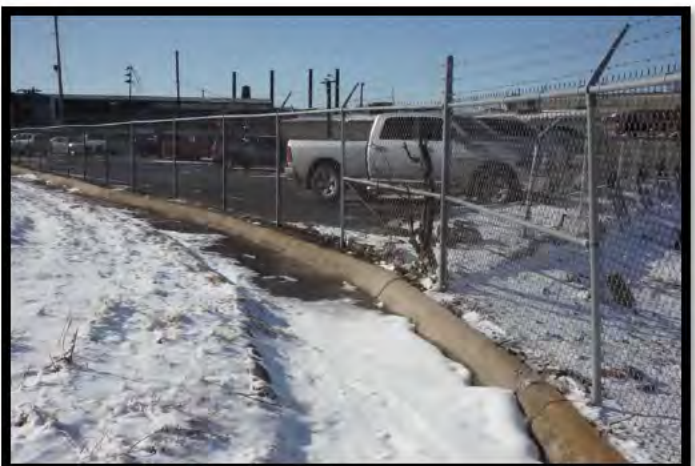
Photograph 12: Concrete drainage swale, fence, and vegetation; north side of Taracorp pile along 16<sup>th</sup> Street (view northwest).

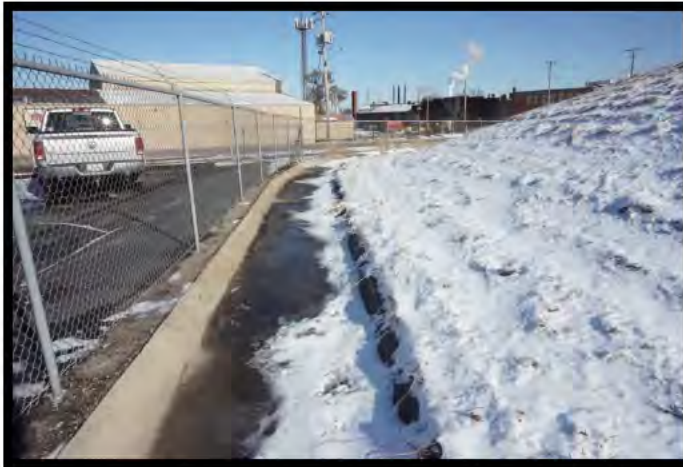
Photograph 13: Concrete drainage swale and vegetation; northwestern side of Taracorp pile (view northeast).

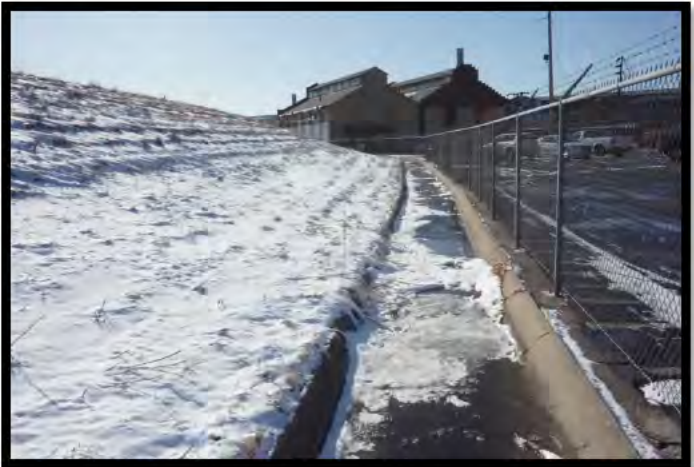
Photograph 14: Vegetation, northwestern side of Taracorp pile cap (view southwest).

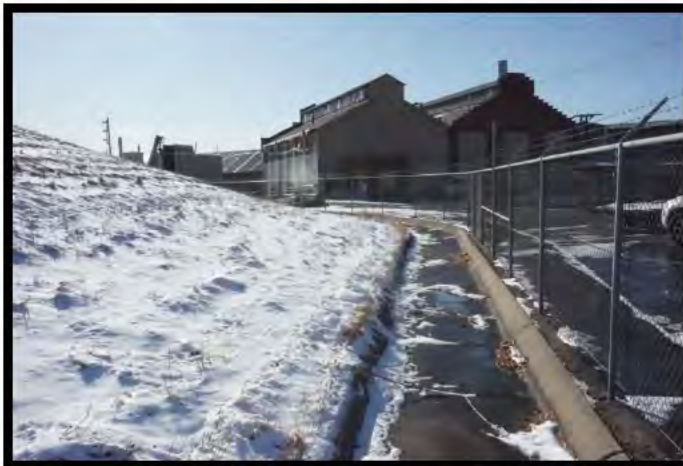
Photograph 15: Concrete drainage swale, fence, and vegetation along northwestern side of Taracorp pile (view southwest).

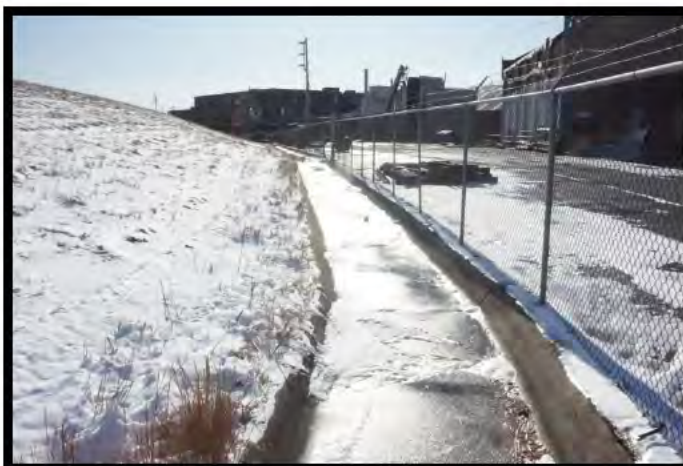
Photograph 17: Concrete drainage swale, fence, and vegetation along northwestern side of Taracorp pile (view southwest).

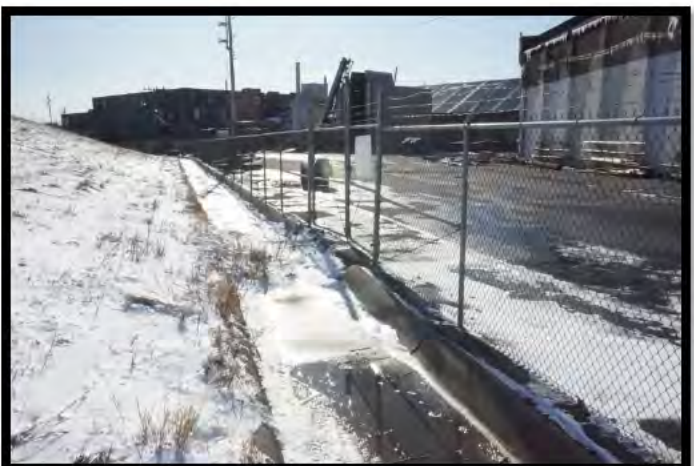
Photograph 18: Concrete drainage swale, fence, and vegetation along northwestern side of Taracorp pile (view southwest).

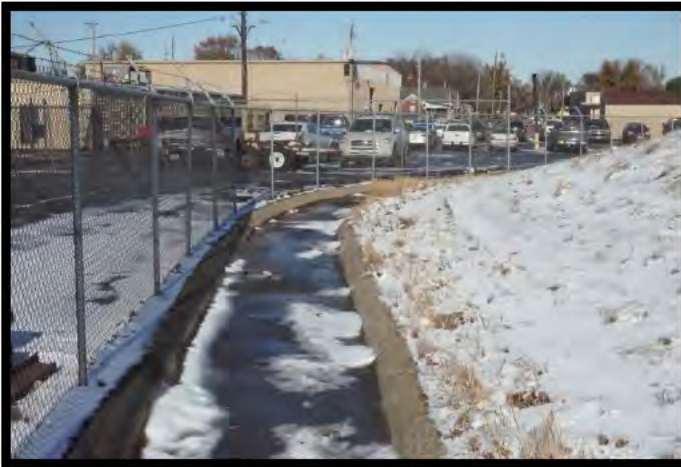
Photograph 19: Concrete drainage swale, vegetation along northwestern side of Taracorp pile (view north/northeast).

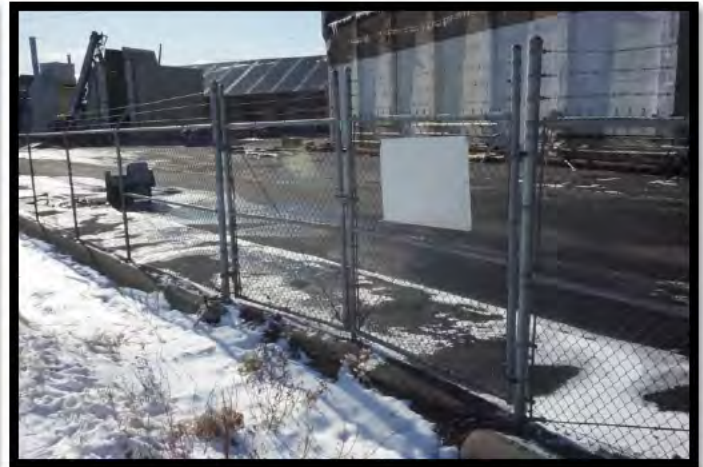
Photograph 20: Fence, warning sign, western side of Taracorp pile.

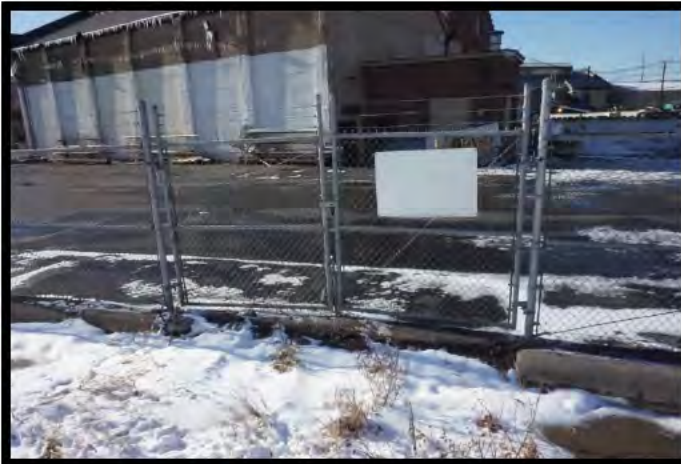
Photograph 21: Fence, warning sign, western side of Taracorp pile.

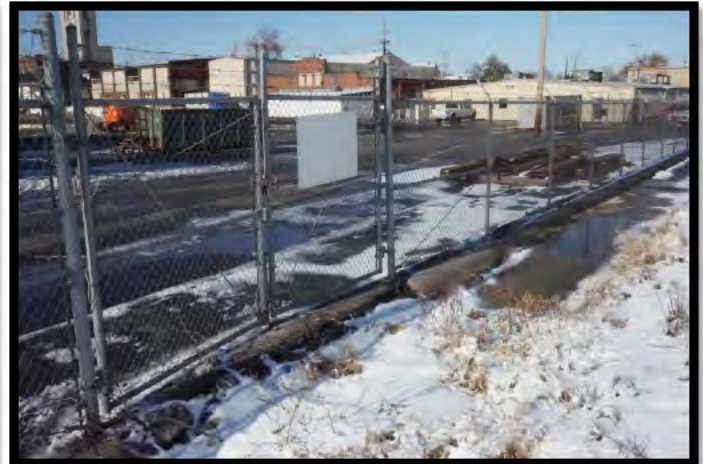
Photograph 22: Fence, warning sign, western side of Taracorp pile.

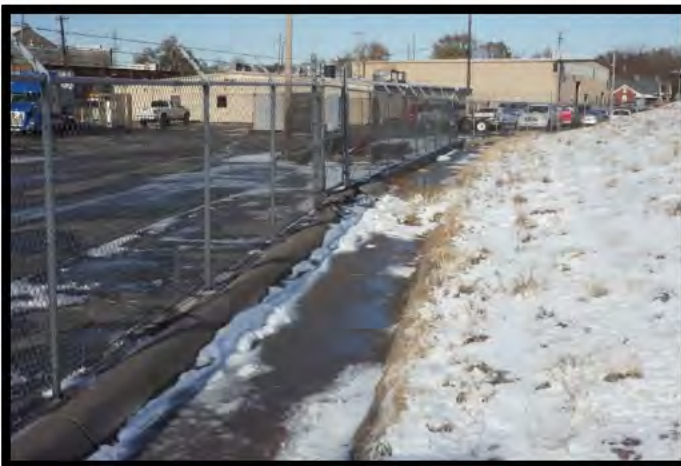
Photograph 23: Vegetation near base of western side of Taracorp pile (view north).

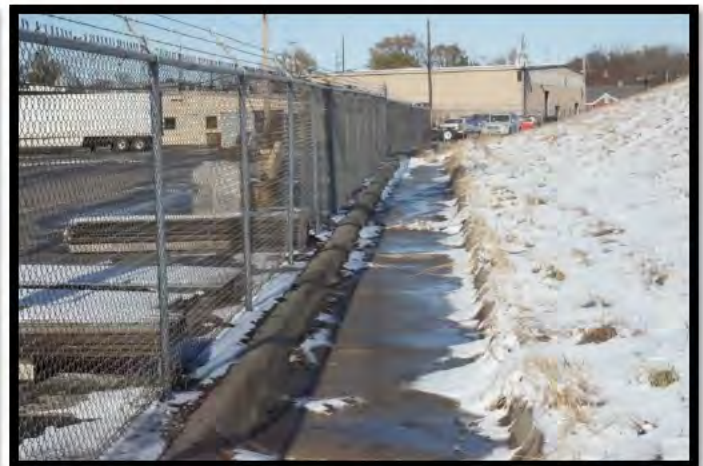
Photograph 24: Concrete drainage swale and vegetation near base of western side of Taracorp pile (view north).

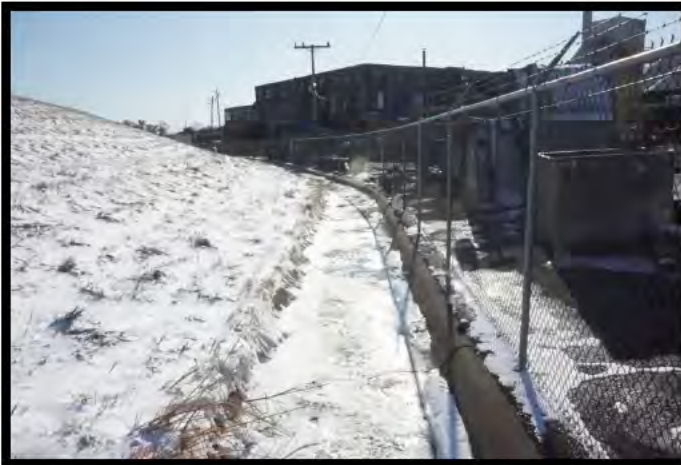
Photograph 25: Concrete drainage swale and vegetation near base of western side of Taracorp pile (view south).

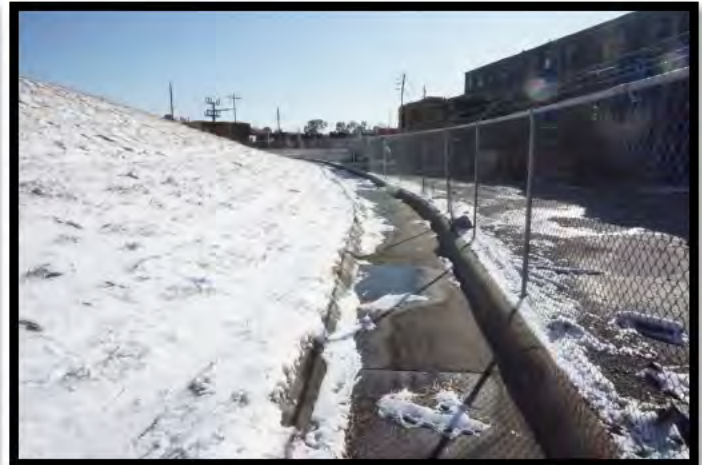
Photograph 26: Concrete drainage swale and vegetation near base of western side of Taracorp pile (view south).

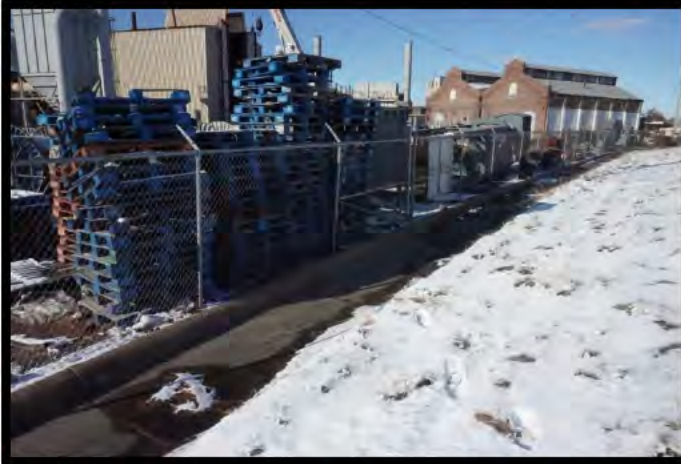
Photograph 27: Concrete drainage swale and vegetation near base of western side of Taracorp pile (view north).

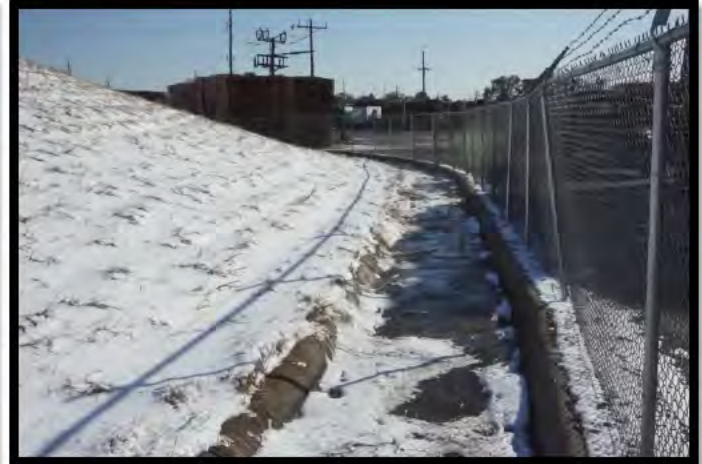
Photograph 28: Concrete drainage swale and vegetation near base of western side of Taracorp pile (view south).

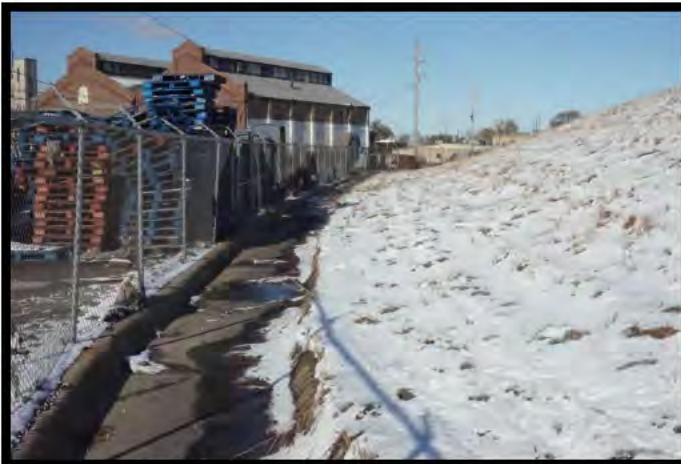
Photograph 29: Concrete drainage swale, western side of Taracorp pile (view north).

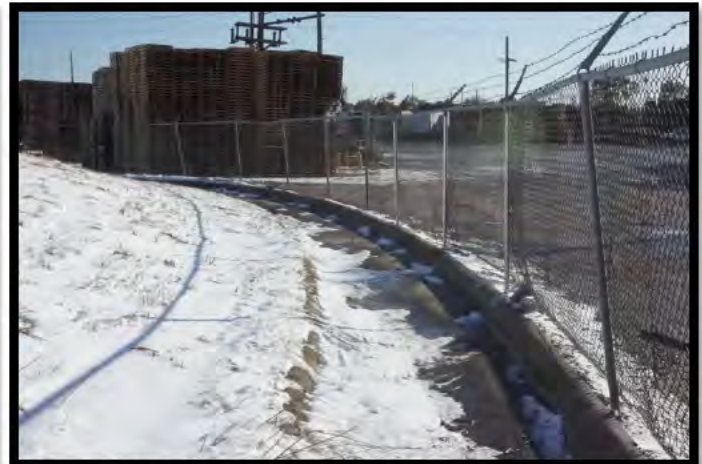
Photograph 30: Concrete drainage swale and vegetation near base of western side of Taracorp pile (view south).

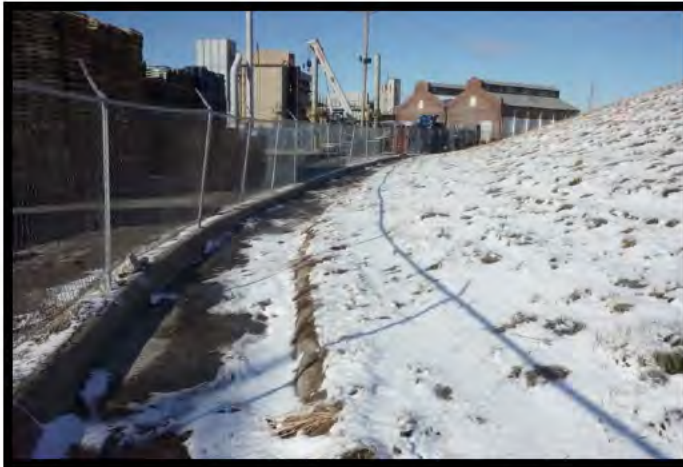
Photograph 31: Fence and concrete drainage swale, southwestern side of Taracorp pile cap (view north).

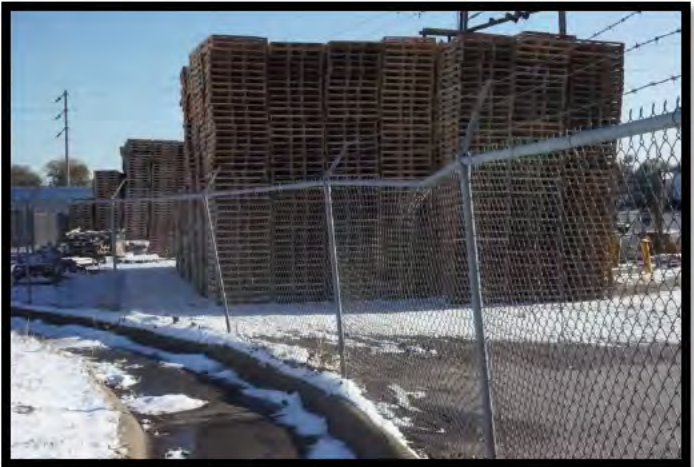
Photograph 32: Fence and concrete drainage swale, southwestern side of Taracorp pile cap (view south).

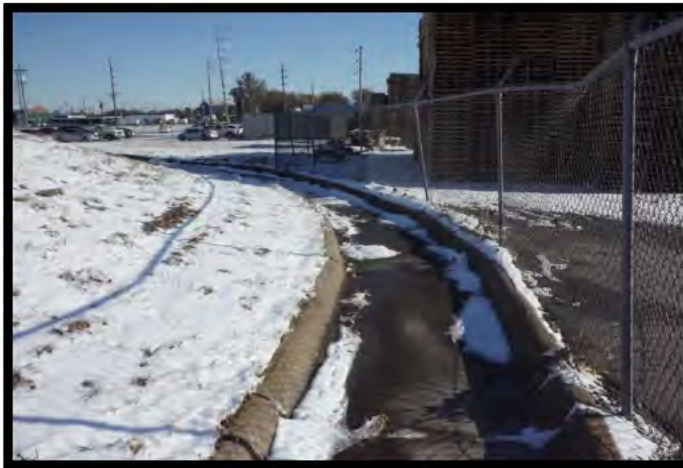
Photograph 33: Fence and concrete drainage swale, southwestern side of Taracorp pile cap (view south).

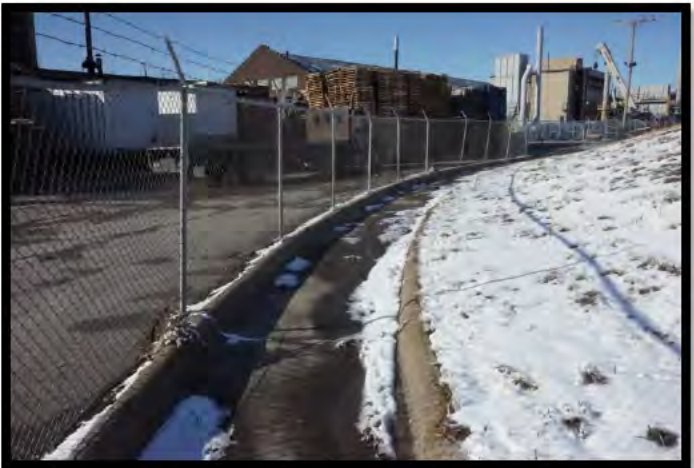
Photograph 34: Fence and concrete drainage swale, southwestern side of Taracorp pile cap (view north).

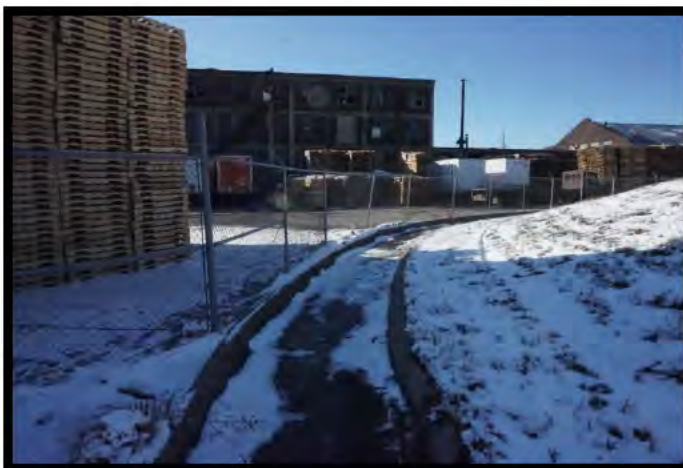
Photograph 35: Fence and concrete drainage swale, southwestern side of Taracorp pile cap (view north).

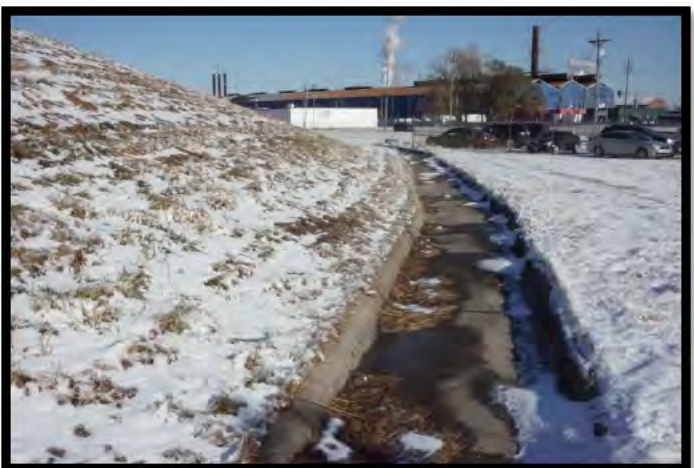
Photograph 36: Fence and concrete drainage swale, southwestern side of Taracorp pile cap (view east).

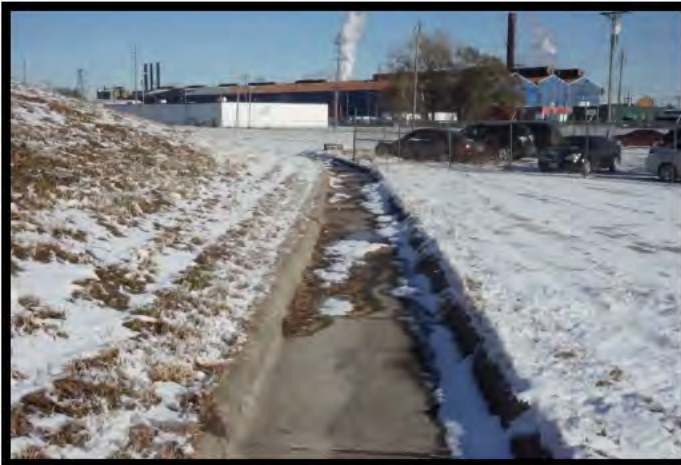
Photograph 37: Fence and concrete drainage swale, southwestern side of Taracorp pile cap (view east).

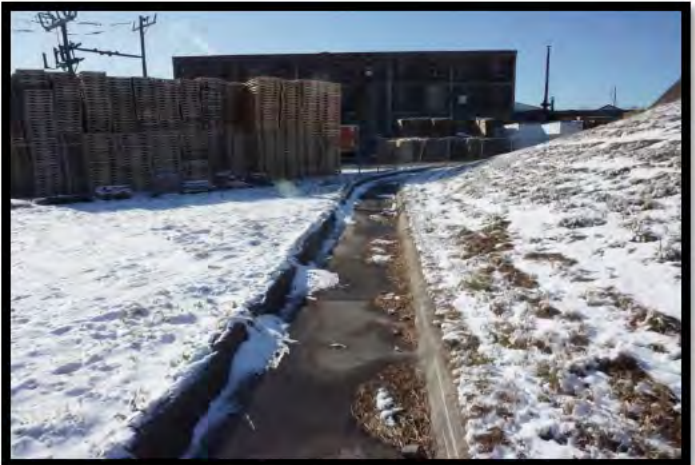
Photograph 38: Fence and concrete drainage swale, southwestern side of Taracorp pile cap (view west).

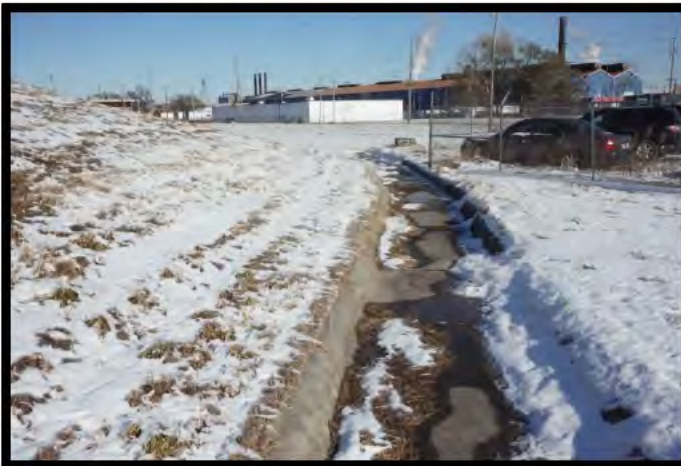
Photograph 39: Fence and concrete drainage swale, southwestern side of Taracorp pile cap (view east).

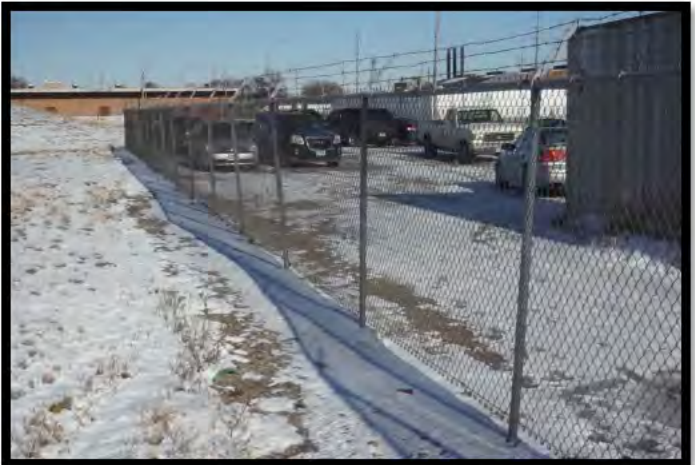
Photograph 44: Fence (parking area on State Street Warehouse property).

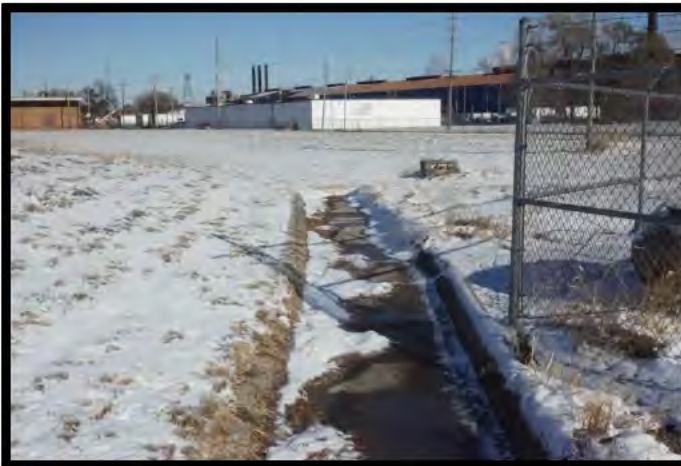
Photograph 45: Vegetation and concrete drainage swale along southern slope of Taracorp pile cap.

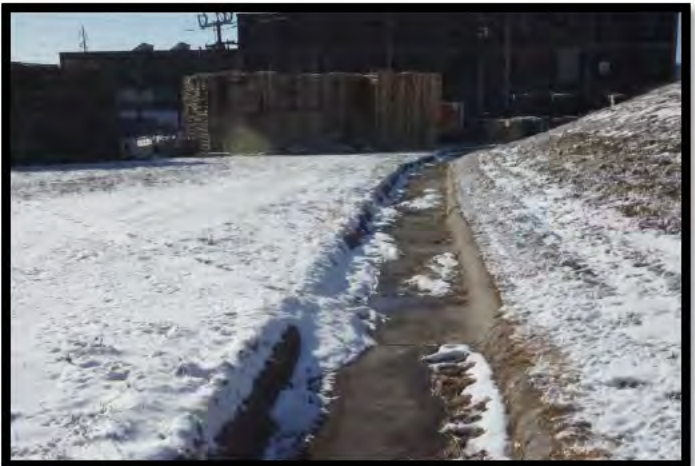
Photograph 46: Vegetation and concrete drainage swale along southern slope of Taracorp pile cap.

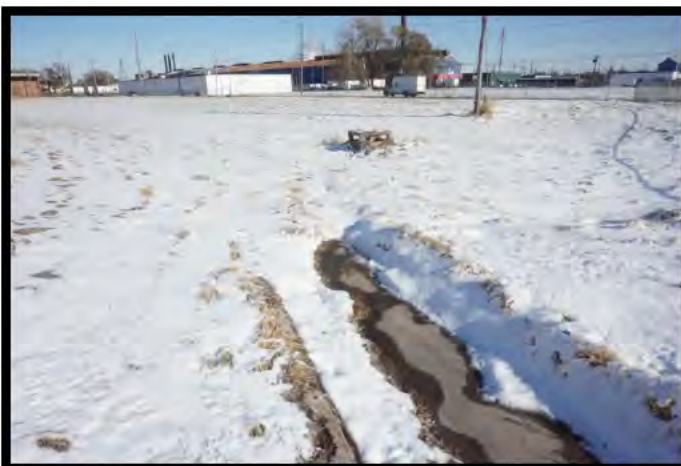
Photograph 47: Concrete drainage swale along southern slope of Taracorp pile.

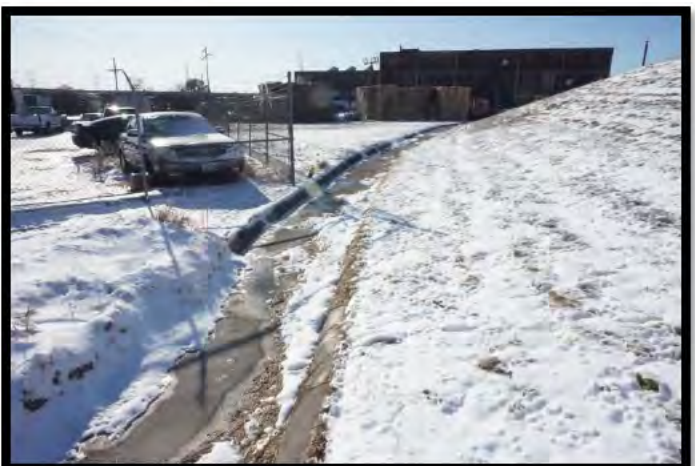
Photograph 48: Concrete drainage swale along southern slope of Taracorp pile.

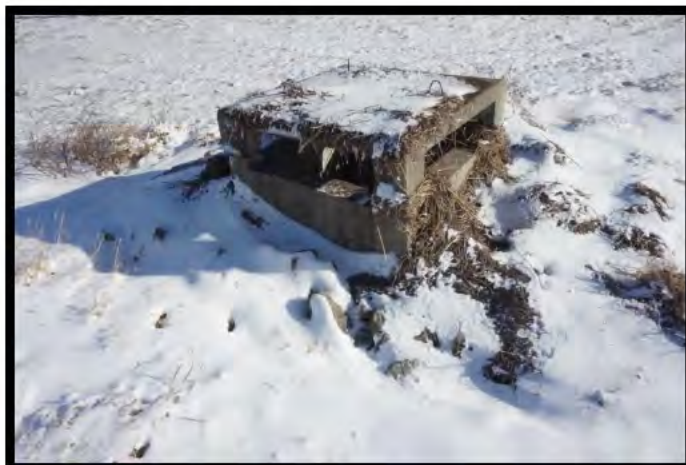
Photograph 49: Southern side of Taracorp pile, stormwater outlet.

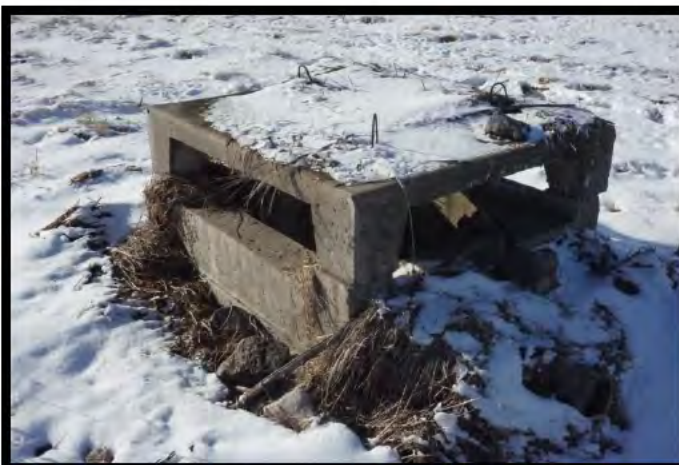
Photograph 50: Stormwater outlet.

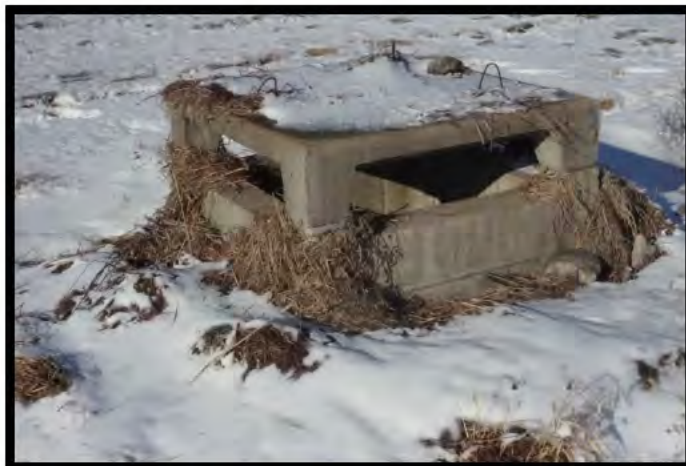
Photograph 51: Stormwater outlet.

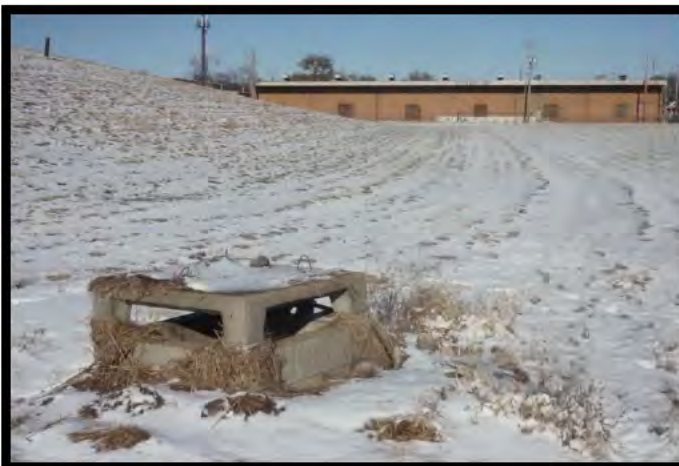
Photograph 52: Stormwater outlet and stormwater retention basin (view northeast).

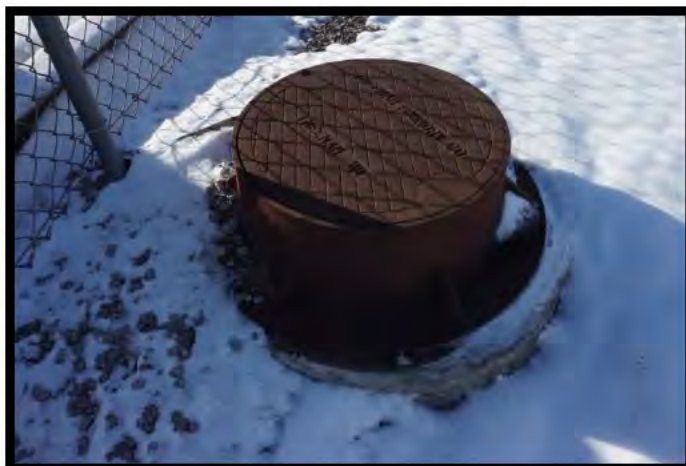
Photograph 53: Stormwater manhole.

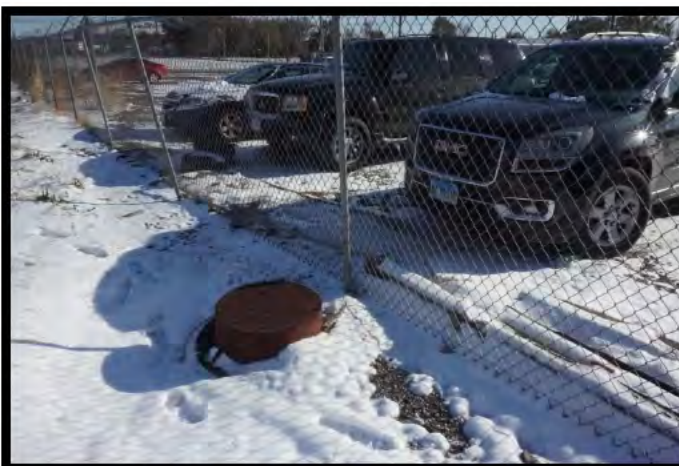
Photograph 54: Stormwater manhole near fence.

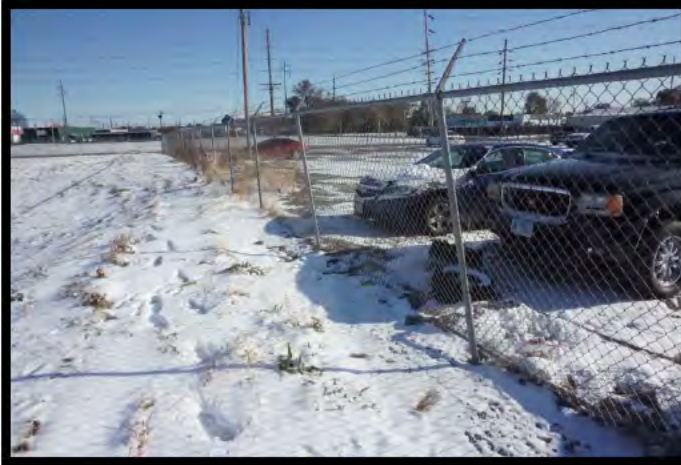
Photograph 55: Vegetation and fence near former Rich Oil facility (view toward State Street).

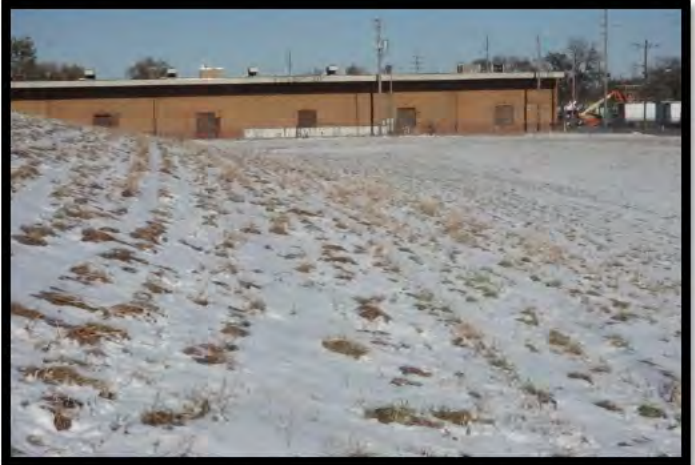
Photograph 56: Vegetation, eastern side of Taracorp pile cap.

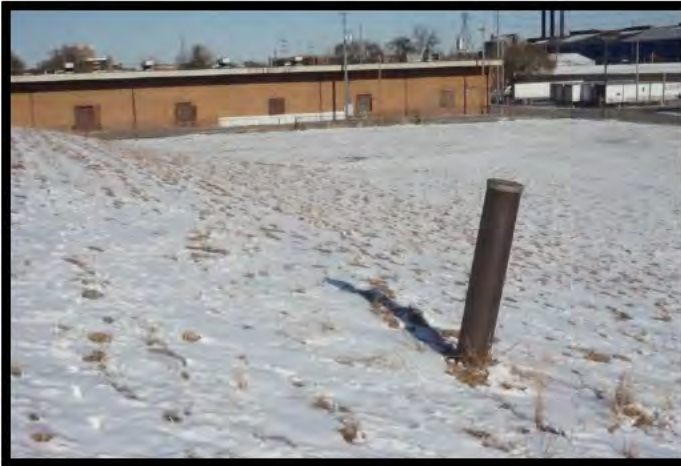
Photograph 57: Leachate riser pipe.

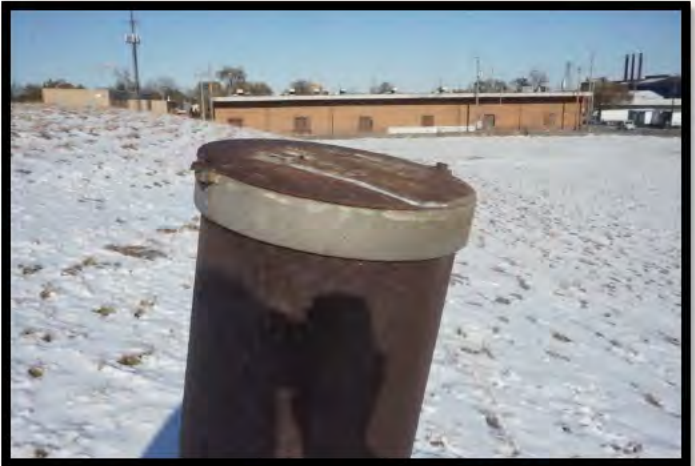
Photograph 58: Locked lid on leachate riser pipe (locked lid installed fall 2007).

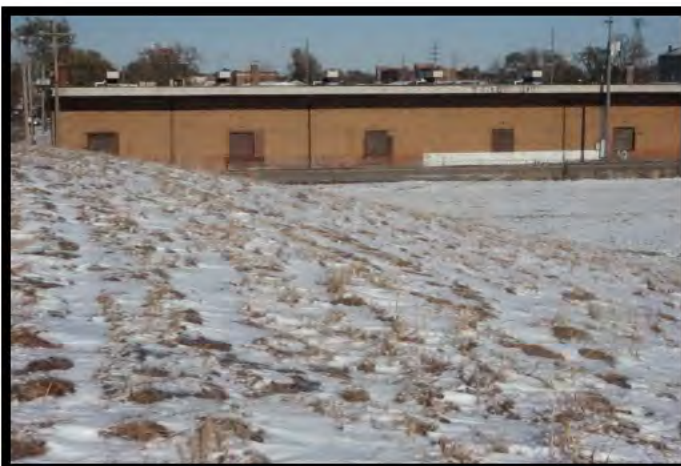
Photograph 59: Vegetation, top of Taracorp pile (view northeast).

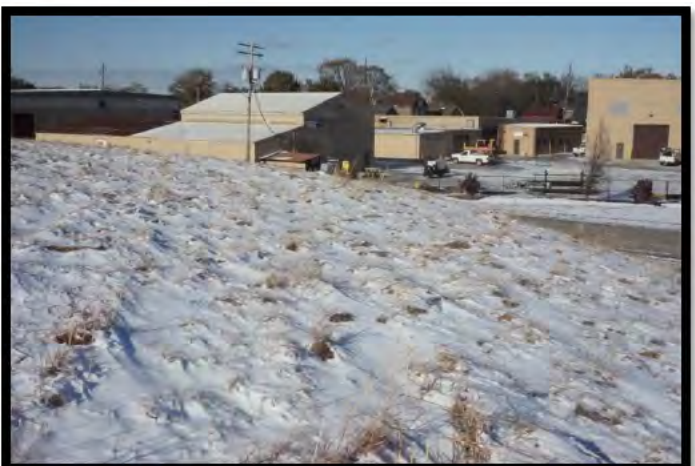
Photograph 60: Vegetation, top of Taracorp pile (view northwest).

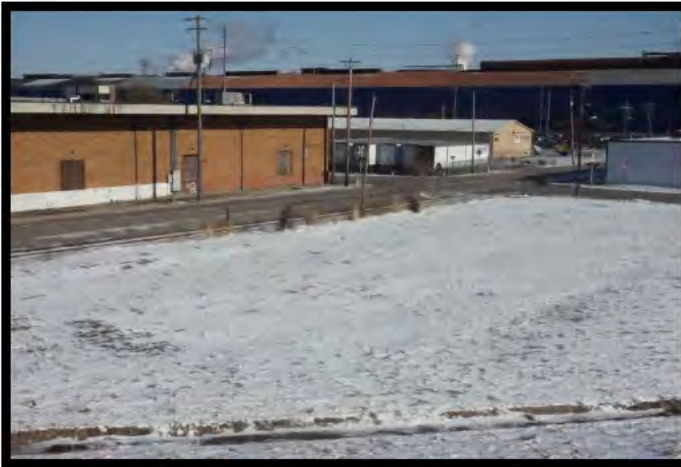
Photograph 61: Vegetation, former BV&G Truck Service area.

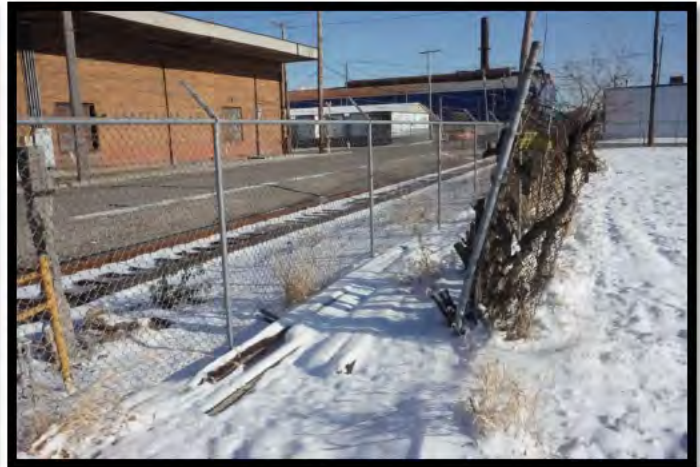
Photograph 62: Older and newer fence near former BV&G Truck Service buildings and along railroad tracks (view northeast).
